**From:** Dana Swift  
**To:** Webb Research, Gary DiBona  
**Date:** February 9, 2021  
**Subject:** Apex Pneumatic Bladder Air Entrapment & Darcy Loss

In December, 2020, UW discovered systematic pathology of the pneumatic system for almost all APEX purchased for the 2018-2019 period. In Fall, 2018, UW placed orders for 110 APEX (ie., all with Apf11 controllers) which were delivered in the first half of 2019. Of these, 104 APEX exhibit pathological loss of internal air post-deployment as evidenced by the steady decrease in internal barometric pressure. This represents a sudden drastic change when referenced against the 47 APEX with Apf11 controllers that were purchased for the previous (ie., 2017-2018) period.

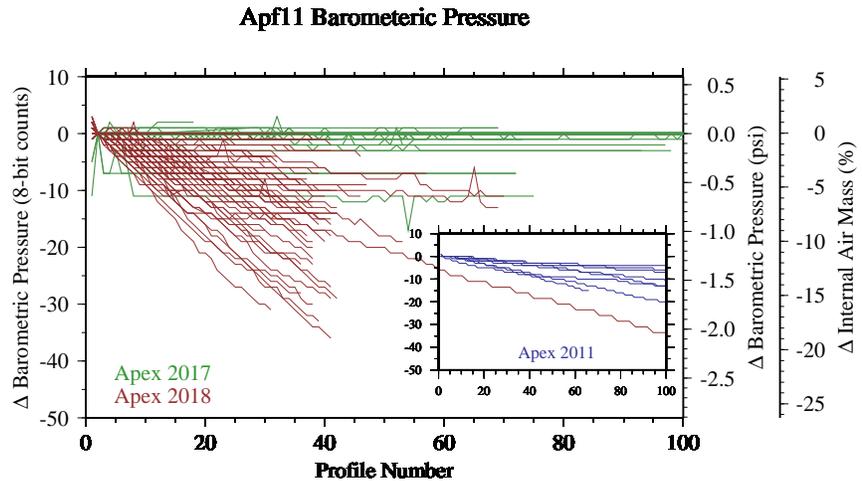
Figure 1: Green curves represent the reference batch of 47 APEX purchased in 2017; only 2 of 47 floats (ie., 4%) exhibit pathological decrease of barometric pressure. Red curves represents the 110 APEX purchased in 2018; 104 of 110 floats (ie., 95%) exhibit pathological decrease of barometric pressure. Historically, this pathology is uncommon although a smaller batch of floats from the 2011 purchase were similarly affected (see inset above).

Fig. 1 reveals that Apf11 floats purchased in 2017 exhibit normal behavior; only 2 of 47 floats (ie., 4%) suffered a pathological decrease in barometric pressure. The red curves show why we sounded the alarm; 104 of 110 floats (ie., 95%) show a steady decrease in barometric pressure which indicates that air is somehow leaving the system.

where the proportionality constant is  $k = \frac{V}{R_s T}$ . The right-most axis in Fig 1 shows the fractional decrease of internal air mass corresponding to the decrease in barometric pressure. The pneumatic pathology causes the loss of 5%-20% of the initial mass of air in the float after only one year of operation.

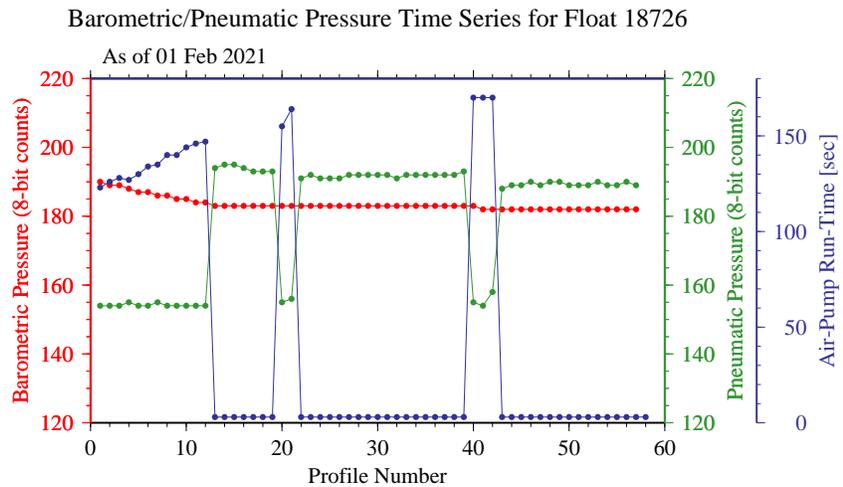
Figure 2: The red time-series represents barometric pressure measurements made at the end of the park phase. The green time-series represents the pneumatic pressure measured at the surface just after the air pump was shut-off. The blue time-series represents the length of time (in seconds) required for the air pump to charge the pneumatic system.

Float 18726 was selected because it provides the cleanest symptoms from which to build a conceptual model. It represents a canonical example that should be used to evaluate hypotheses that might explain the syndrome's cause. Fig. 2 very clearly illustrates the first three symptoms listed above.

During the first 12 profiles, both air-pump run-time and pneumatic pressure indicate successful bladder inflation. However, decreasing barometric pressure during these profiles indicates loss of internal air from the system.

Starting with profile 13, the pneumatic system is over-pressurized to  $\sim 190$  counts after running the air pump only 3 seconds. This indicates that only the Tygon tube connecting the air pump to the air bladder is being charged; the air bladder itself remains deflated. Simultaneously, barometric pressure levels off which indicates that no additional air is lost from the system. *This observation directly connects (and implicates) the pneumatic bladder with the loss of internal air; air loss happens only when bladder inflation is at least partially successful.*

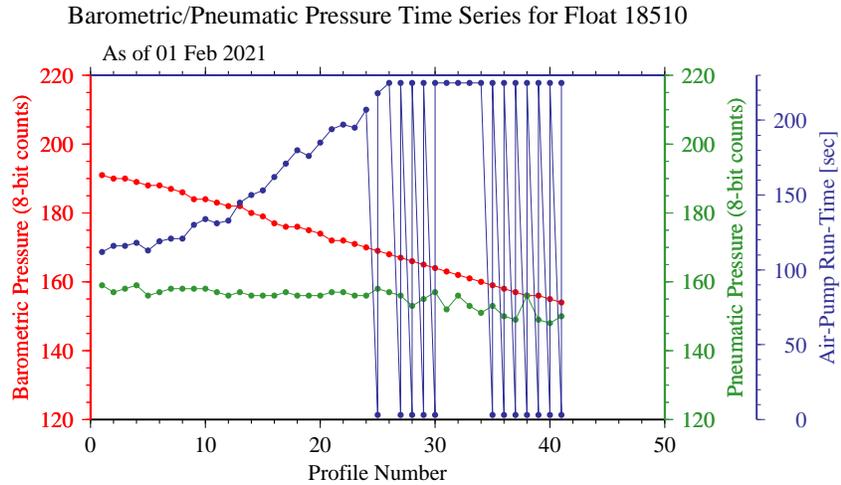
Figure 3: The blue curve shows that symptom (3) is intermittent and temporary. When the symptom occurs, bladder inflation is prematurely terminated only on the first telemetry cycle; the second telemetry cycle is always successful.

Fig. 3 shows strong and steady decreasing internal pressure. According to (2), the decrease of barometric pressure by 36 counts corresponds to the loss of 19% of its initial mass of air.

As the air pressure drops, the run-time of the air pump increases up to 225 seconds which is the maximum allowed by firmware.

Starting with profile 25, symptom (3) appears intermittently. During the telemetry phase, as many telemetry cycles are executed as necessary to upload all of the data. If a telemetry cycle ends with data still to be uploaded then the float sleeps for a few minutes before initiating another telemetry cycle.

All of the profiles in Fig. 3 that exhibit two different run-times required multiple telemetry cycles. All experienced the same pattern of behavior. During the first telemetry cycle, the air pump ran for only 3 seconds after which the pneumatic pressure measured approximately 190 8-bit counts. This far exceeds the cut-off threshold of 154 counts and so indicates that something prevented air from inflating the air bladder. However, this condition is temporary because bladder inflation is successful on the second telemetry cycle.

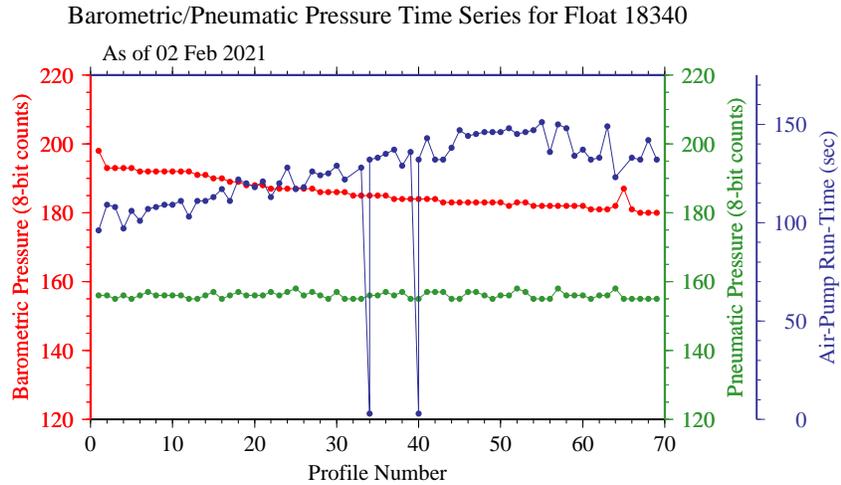
Figure 4: Despite exhibiting relatively mild pathology, float 18340 was crucial to discovering the syndrome’s cause.

Fig. 4 shows that this float was relatively mildly affected by the syndrome despite exhibiting three of the four symptoms listed previously. The barometric pressure dropped from 193 (on profile 2) down to 180 which indicates a loss of 7% of its air mass. The float remained at the surface for the entirety of profile 65 indicating that enough air was trapped in the air bladder or hydraulic system to prevent its descent. Warmer temperatures at the surface explain the upward blip in the barometric pressure during profile 65. Two instances of sticky-bladder occurred during profiles 34 & 40 that initially prevented bladder inflation. In both cases, the bladders were successfully inflated on subsequent telemetry cycles.

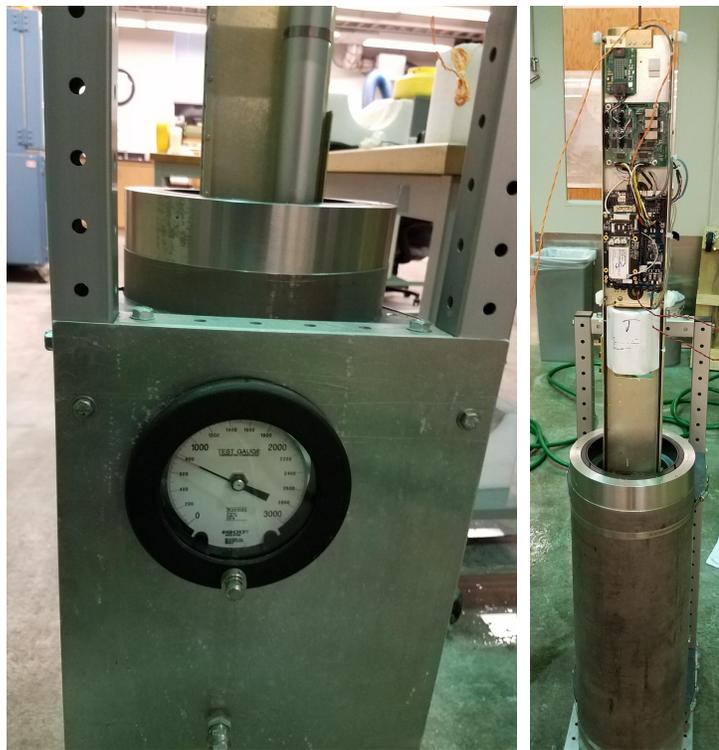
Figure 5: This pressure test vessel (PTV) was custom designed to subject the lower end-cap assembly to high pressure water while simultaneously allowing access to the inside of the float.

Fig. 5 shows UW's small PTV that was custom designed to subject the lower end-cap assembly to the full range of water pressure while simultaneously allowing access to the inside of the float. It includes provision to bleed air at its highest point so that the internal volume is completely filled with water.

The float was mounted in the PTV and its solenoid valve opened to allow the air bladder to deflate. The PTV was initially charged with normal city water pressure (ie.,  $\sim 60$  psig) before closing a valve to render a closed system that could be further pressurized using the float's hydraulic pump. The Apf11 was used to control and measure the piston position. The water pressure increased as the piston was extended and the PTV's gauge was used to measure pressure.

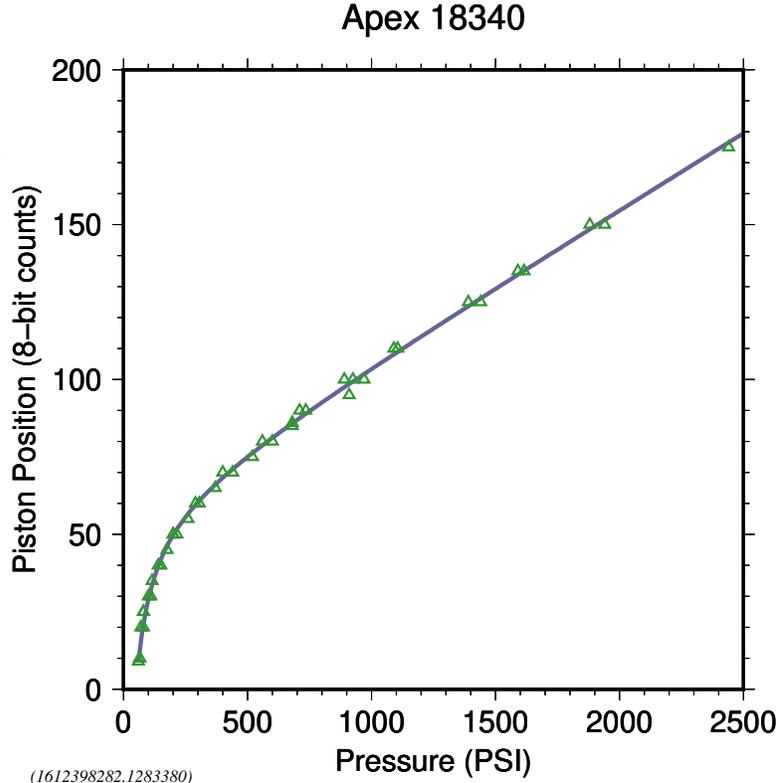
Figure 6: The green triangles represent 44 measurements of the volume displacement (ie., piston position) as a function of pressure. The blue curve represents a weighted least-squares best-fit to a mathematical model of associated physics. The nonlinear character of the P-V curve is the hallmark signature of the presence of air in the hydraulic system. Moreover, the curve's concavity quantitatively encodes the volume of trapped air.

The volume displacement (ie., piston position) was measured over the range of pressures from approximately  $60 \leftrightarrow 2500$  psig. The range was traversed four times in patterns of increasing and then decreasing pressure. The green triangles in Fig. 6 represent 44 measurements of the volume displacement (ie., piston position) as a function of pressure.

All of the quantities in (5) are directly measured except for the two unknowns:  $\left. \frac{\partial V}{\partial P} \right|_{\ell}$  and k. The 44 measurements were used to solve for these two unknowns using a standard weighted least-squares method. The blue curve in Fig. 6 represents the function,  $c(P)$ , that is a best-fit to the 44 measurements. The function is derived by solving (5) for (c) and considering all quantities, except (P), to be known parameters. The variable (P) determines the volume displacement and its partitioning according to (5).

The correctness of the model physic seems evident by the closeness of the blue curve to the green measurements in Fig. 6, Having formulated the model, it is now possible to compute the volume of the air bubble to be  $V_a = 149 \text{ ml}$  at atmospheric pressure.

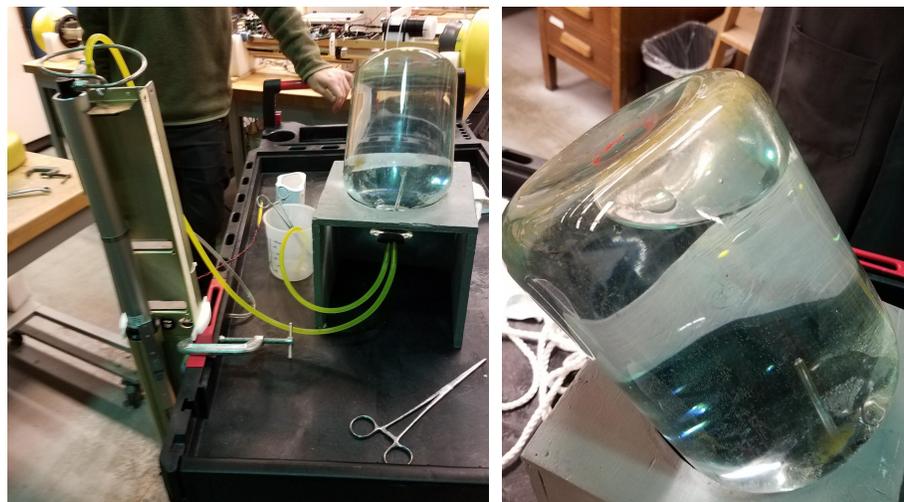
Figure 7: (left) The trapped air bubble was extracted using an inverted jar filled with water and a beaker to measure the volume of water displaced by the recovered air bubble. (right) The large (110ml) air bubble is shown in the top of the inverted jar after the extraction process was complete.

Tygon tubing was connected from an inverted jar to the oil line as shown in Fig. 7. A second Tygon tube would empty water into a beaker so that the volume of displaced water could be measured. The Tygon tubes and inverted jar were completely full of water. As shown in Fig. 7, the float chassis was inverted and clamped so that the air bubble would rise to the top of the inverted cylinder. The Apf11 was used to extend the piston to push the air bubble out of the cylinder, through the tygon tube, and into the jar. The air bubbles floated to the top of the jar while the displaced water was collected in the beaker to be measured. The hydraulic pump was allowed to run until all of the air was discharged from the cylinder; the volume of air was measured to be 110ml.

The large air bubble shown in the top of the jar in Fig. 7 displaced 110ml of water into the beaker. This represents only 74% of the 149ml that was measured by the noninvasive method described in the previous section. The source of this discrepancy is unknown but possibilities include that not all of the air was recovered by the extraction process or perhaps the noninvasive method over-estimated the volume if not all of the air was bled from the PTV.

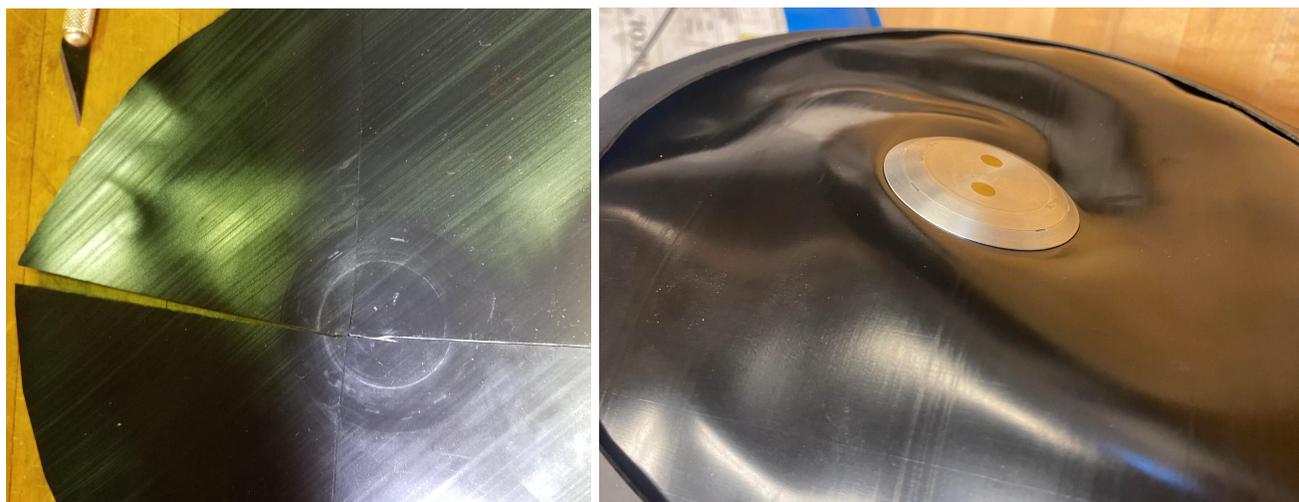
Figure 8: **ApfId 18340 Bladder Section:** (left) The inner surface of the outer wall of the air bladder is marked by linear striations with a median transverse roughness (Ra) measured to be  $16\mu\text{m}$ . (right) The inner surface of the inner wall of the air bladder is smooth and shiny with only a few striations. The median roughness was measured to be  $12\mu\text{m}$ .

The air bladder from ApfId 18340 (WrcId 8686) was sectioned and examined. For comparison purposes, ApfId 17762 (WrcId 8369) was selected as a reference because its air bladder originated from a previous batch of floats that were unaffected by the pathology. Figures 8 and 9 show photographs of the mating surfaces of the outer and inner walls of the air bladders for the affected and reference floats, respectively. Based on a qualitative visual and tactile examination, both surfaces of the reference bladder (Fig. 9) are characterized by linear striations and a rough appearance. As will be described later, both of these features are crucial to prevent air from being trapped in the bladder. In contrast, the mating surfaces of the affected float (Fig. 8) are much smoother with striations almost completely absent on the inner wall.

The mating surfaces of the affected and reference air bladders were measured using a roughness gauge. Table 1 lists the measurements for each surface in increasing order of roughness (Ra); the median values are displayed in bold. The quantitative measurements confirm the qualitative observation that the roughness of the reference bladder is much higher than the affected bladder. This is particularly true for the inner wall where the roughness of the reference bladder is 3.4 times than the affected bladder. These measurements will form the basis for a conceptual model of the pathology.

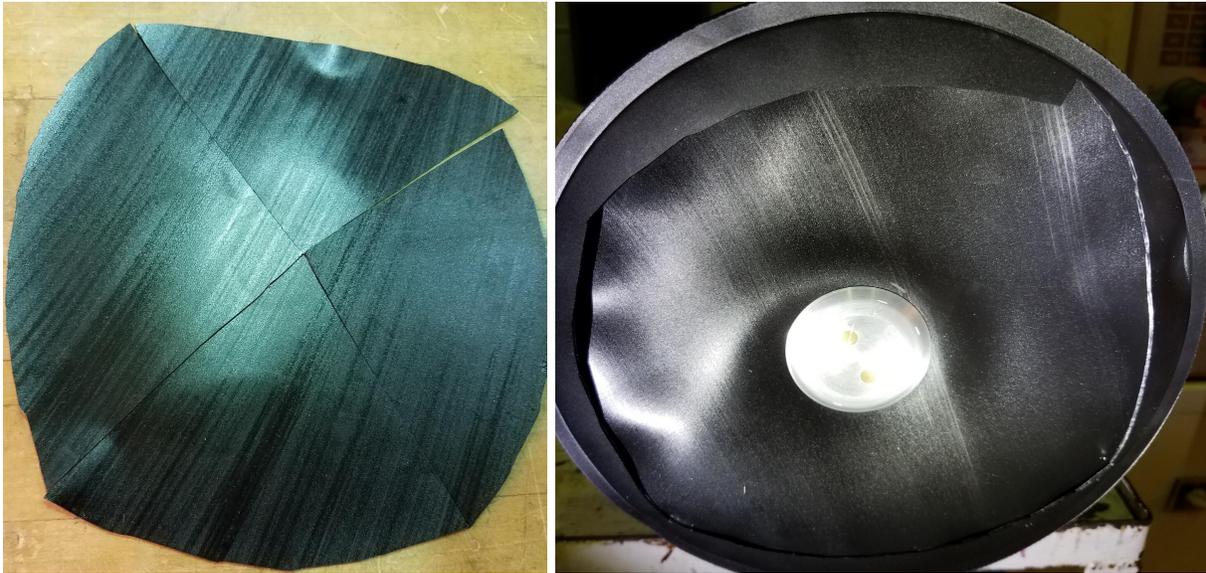
Figure 9: **Apfld 17762 Bladder Section:** (left) The inner surface of the outer wall of the air bladder is marked by linear striations with a median transverse roughness ( $R_a$ ) measured to be  $27\mu\text{m}$ . (right) The inner surface of the inner wall of the air bladder has distinct linear striations and a median roughness  $40\mu\text{m}$ .

The reference bladder shown in Fig. 9 and its surface roughness as measured in Table 1 will be used to

specify bladders with adequate radial porosity.

Table 1 makes clear that there is a distinct measurable difference in the surface roughness (measured transverse to the striations) of the reference bladder in comparison to the bladder from float 18340. Based on these measurements, we will propose that the presence of striations with a minimum median surface roughness ( $R_a$ ) of  $25\mu\text{m}$  be required of the sheets of material used to make the bladders. The striations on each wall of the air bladder should be obliquely oriented and facing each other. In addition, the minimum durometer of the material should be 80 on the Shore A scale to prevent the channels from collapsing under pressure.

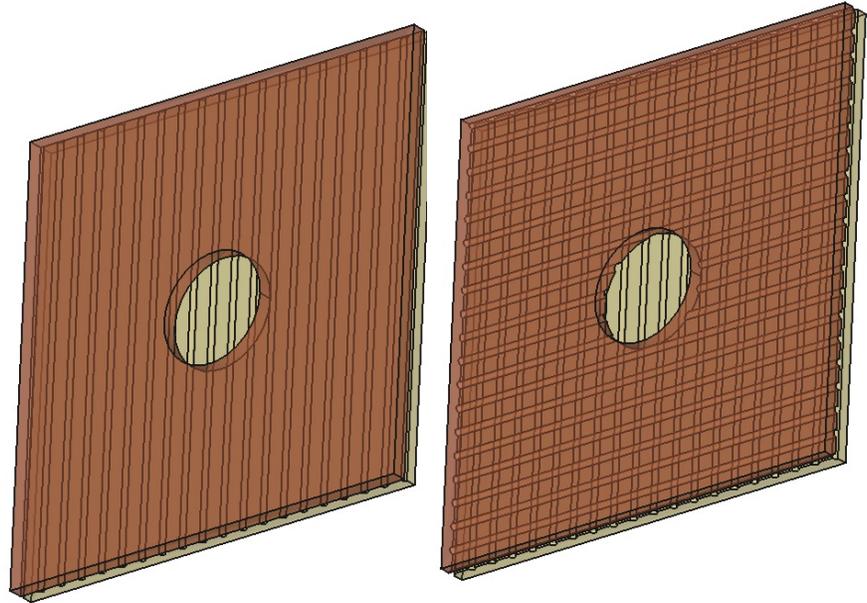
Figure 10: This cartoon model of the portion of air bladder near the fitting reveals the importance of striations on the surfaces of both walls. (*left*) For most sectors, striations on only one surface prevent access to a channel that intersects the center fitting. (*right*) Obliquely oriented striations on both walls facilitate channels that connect the center fitting to anywhere in the bladder.

Fig. 10 shows a cartoon model of an area near the center fitting of the deflated air bladder and hint that the striations form channels through which air can flow in response to a pressure gradient. Fig. 10L depicts a bladder where the inner wall lacks striations (ie., float 18340). Most striations do not intersect the center fitting and so trapped air can not flow back inside the float. On the other hand, Fig. 10R depicts a bladder with obliquely-intersecting striations on both walls. The cross-hatched pattern of intersecting channels facilitates air flow radially inward toward the center fitting from anywhere within the bladder. The enhanced radial Darcy flow allows the air bladder to completely deflate and so prevents air loss from the system.
